Excavation and Investigation of a Permeable Reactive Barrier in Cañon City, Colorado

Permeable Reactive Barrier

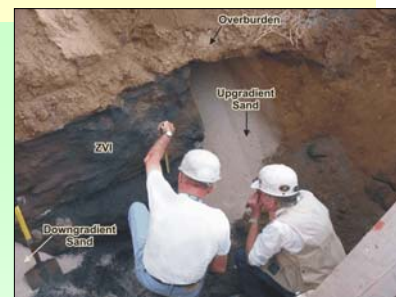
In October 2004, west end of PRB exposed in an excavation to provide direct observation of the ZVI

- ZVI had become cemented
- Solid-phase Mo to 4,050 µg/g; highest values within 0.5 ft of upgradient front of PRB
- Solid-phase calcium (Ca) to 44,200 µg/g; high throughout most of the ZVI
- Microscopy results indicate that calcium carbonate occurs as crystalline blades
- Crystals often are grown into pores and occlude some of the porosity
- Iron oxides prevalent and further decrease porosity
- Late-stage sulfides overlie and intermix with other corrosion products

Excavation showing rigid wall of ZVI.
